FARR
Air Pollution Control

Case Study

Don't Let This Happen to Your Clean Air System

Product: HemiPleat®
Size: GS16
Application: Metal
Customer: Quantum Metals-Lebanon, Ohio
Representative: Air/Pro

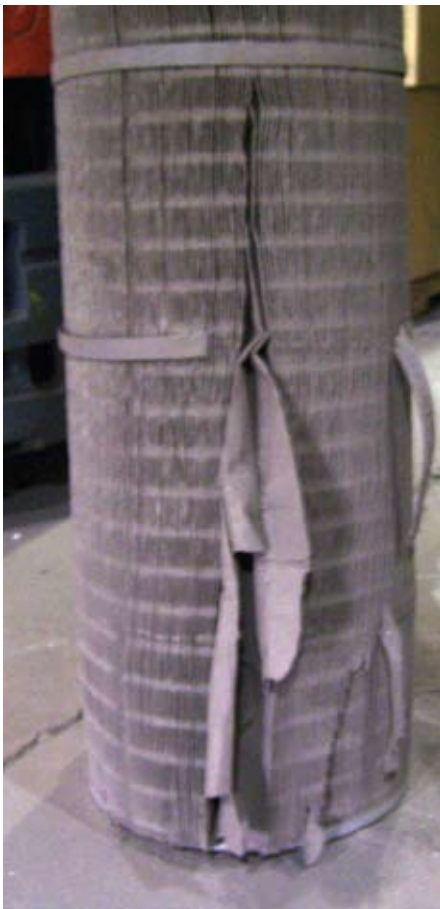
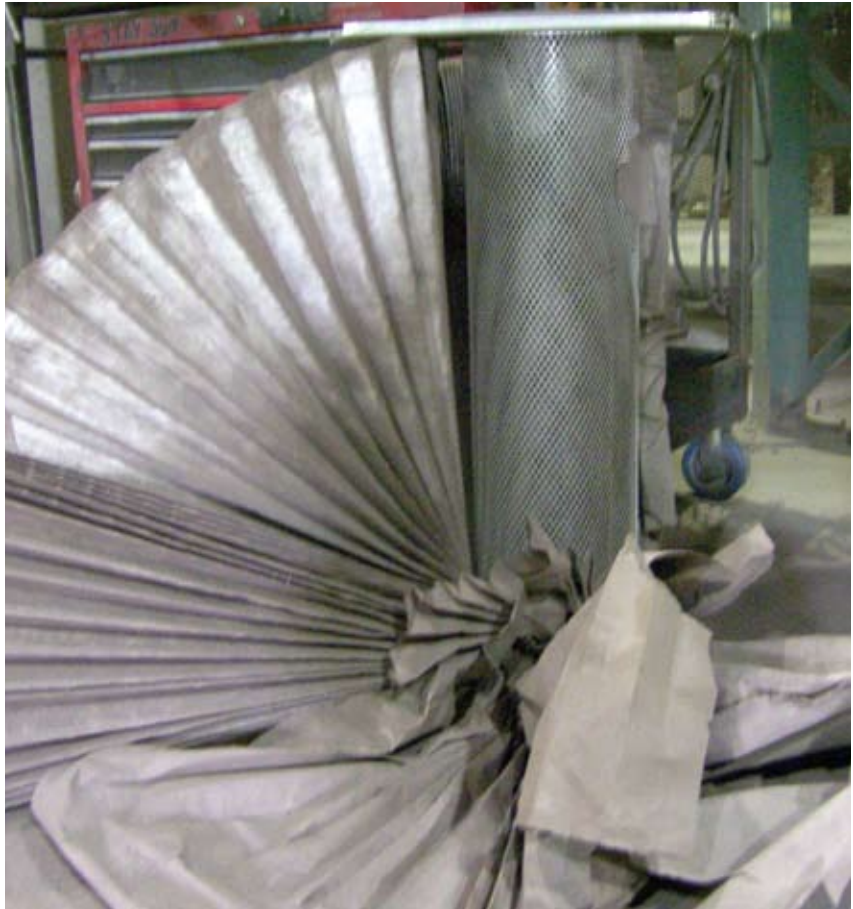
Not all aftermarket filters can withstand the power of the Gold Series® cleaning system.

Fuchs contacted Farr APC when the second round of aftermarket filters failed. The aftermarket filters could not withstand the pressure from the pulsing of the Gold Series®. Nylon straps which hold the filter together came off and the filter paper became unglued. Flanges were warped, seals ruptured, and bottom pans separated.

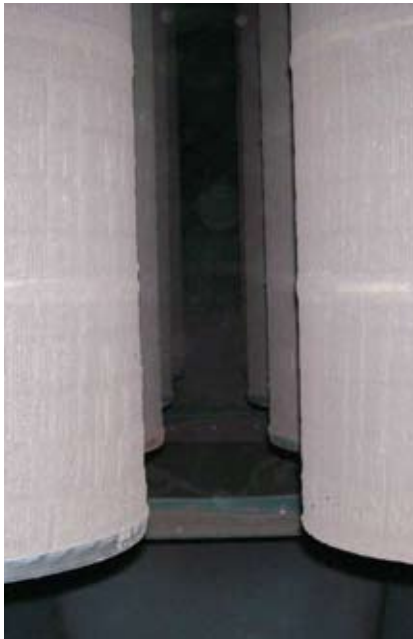
These filter pleats are plugged full of dust.

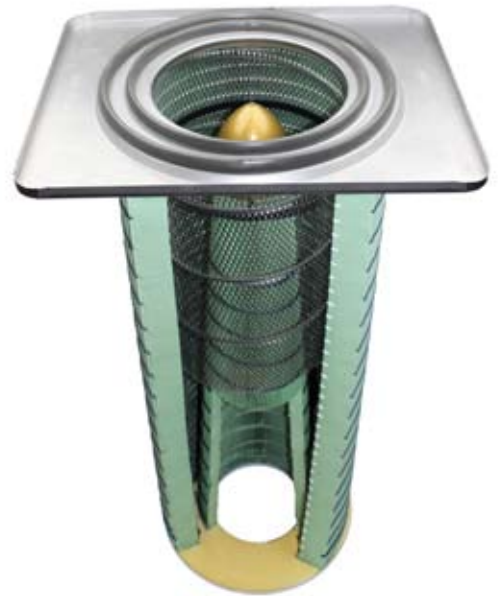
HemiPleat® has more available/usable media for filtration.

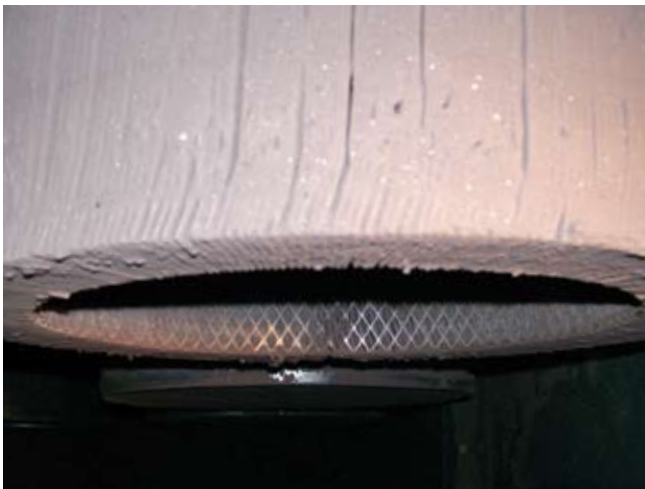
The **bottom** fell out and dust went everywhere.

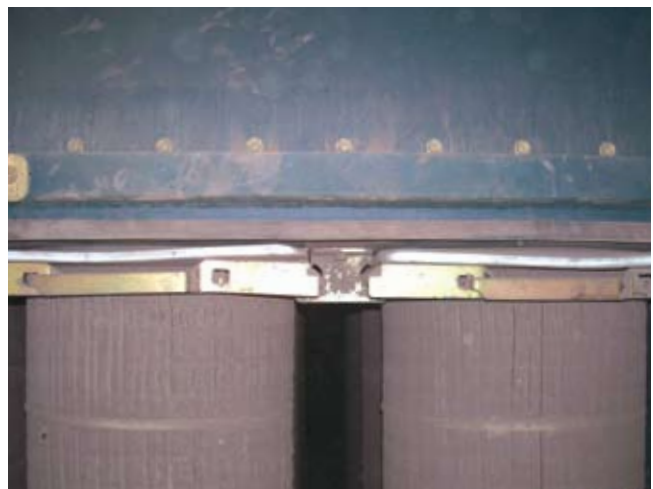
Warped mounting plates encourage gasket leaks.
